**Flood Control Project Maintenance
Levee Inspections**
LMA District Cover Sheet
Spring 2017 Levee Inspection Results

Sutter Maintenance Yard East Levee Sacramento River

Spring 2017 Levee Inspection Results

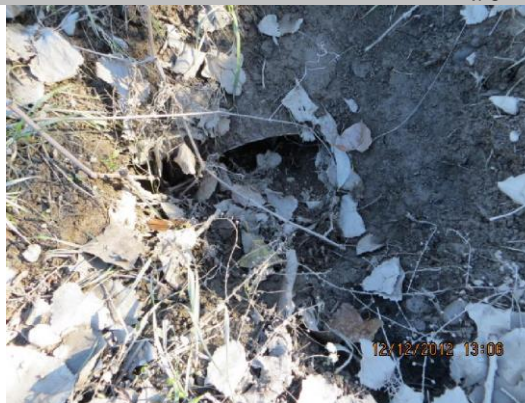
Photo 3 of 3 : UCIP_SP_2017_51688_47157.jpg

Item	DWR UCIP Field Study			39.223796 °	39.223796 °	
				-121.999014 °	-121.999014 °	
DWR ID						
Comment Code						
Inspector Comment						
FS_ID:51688 DS_ID:17306 EP_NO: 9530 Repair Type: Non-Urgent Crossing Status: Found UCIP Comments: 4/16/2017 Abandoned- needs to be done properly. (DWR Sutter Yard- AFreitag)10/31/2016 Appears abandoned. (DWR Sutter Yard- AFreitag)6/1/2016 Appears to be an abandoned crossing. WS end is about 90% buried with soil and the LS end is still unknown.4/1/2015 WS pipe end 3/4 blocked by soil. LS end is still unknown.Pipe outlet on WS partially burried, it needs cleaning.6/30/2014 Same as last inspection.12/18/2013 Same as last inspection.7/23/2013 Same as last inspection FIELD_STRUCT_DESC: *ABANDONED* 30-inch corrugated metal drainage pipe through the levee, 15 feet below the crown. Slide gate in a corrugated metal pipe (CMP) riser on the waterside (WS) slope. (Automatic Board Order (ABO) issued as Permit No. 9530, 1974 - Halsey). [Additional Reference(s): DWR Levee Log, 2002]. FS Date: 4/26/2017 1:45:14 PM

Waterside view: partially buried steel pipe

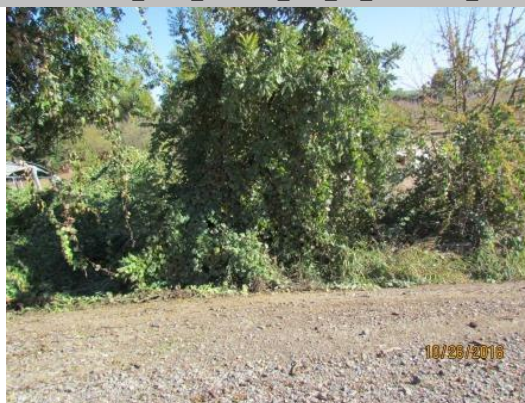
Photo 1 of 1 : SP_2017_ST0003_264_99_20170315_00029.jpg

LM Start	6.47	Rating **	M	Issue No.	99
LM End	6.47	Issue Type +	Ma	Location *	LS
Category	Earthen Levee			GPS Latitude/Longitude	
				Start	End
Item	Vegetation			39.224719 °	39.224719 °
				-121.998623 °	-121.998623 °
DWR ID	DWR_ST0003_01_f_2016_99				
Comment Code					
V2 : Remove the wild growth other than native grasses from the levee slopes.					
Inspector Comment

View of the overgrown vegetation along the landside slope.

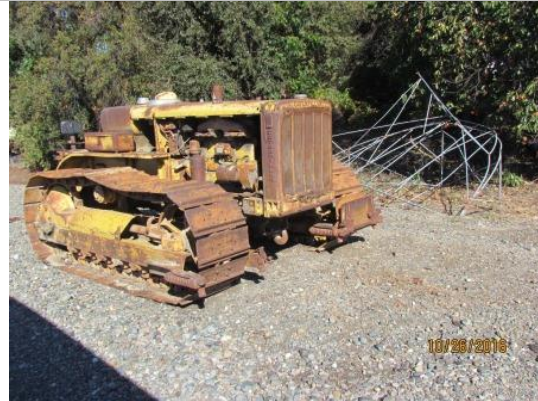
Photo 1 of 1 : SP_2017_ST0003_264_98_20170315_00028.jpg

LM Start	6.51	Rating **	M	Issue No.	98
LM End	6.51	Issue Type +	En	Location *	LS
Category	Earthen Levee			GPS Latitude/Longitude	
				Start	End
Item	Encroachments			39.225307 °	39.225307 °
				-121.998755 °	-121.998755 °
DWR ID	DWR_ST0003_01_f_2016_98				
Comment Code					
EQ : Equipment					
Inspector Comment

View of the ag equipment along the landside toe.

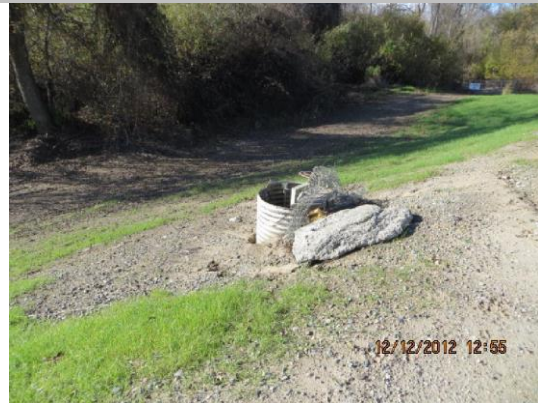
Photo 1 of 2 : UCIP_SP_2017_51689_47181.jpg

LM Start	6.64	Rating **	M	Issue No.	153
LM End	6.64	Issue Type +	En	Location *	LS
Category	Supplemental			GPS Latitude/Longitude	
				Start	End
Item	DWR UCIP Field Study			39.226991 °	39.226991 °
				-121.999907 °	-121.999907 °
DWR ID

Comment Code					
Inspector Comment					
FS_ID:51689 DS_ID:17296 EP_NO: 9530 Repair Type: Non-Urgent Crossing Status: Indicator Found UCIP Comments: 4/19/2017 Abandoned- needs to be done properly. (DWR Sutter Yard- AFreitag)10/31/2016 Abandoned. (DWR Sutter Yard- AFreitag)6/1/2016 Abandoned- only WS riser and screwgate found.4/1/2015 Only cmp riser with screwgate found on WS. Screwgate stem is bent.Appears abandoned and should be verified as having been done so properly. Only CMP riser with slide gate found on WS6/30/2014 Same as last inspection.12/18/2013 Same as last inspection.7/23/2013 Same as last inspection FIELD_STRUCT_DESC: *ABANDONED* 24-inch corrugated metal drainage pipe through the levee, 13.5 feet below the crown, not found in 2015. Slide gate in a corrugated metal pipe (CMP) riser on the waterside (WS) slope, found in 2015. (Automatic Board Order (ABO) issued as Permit No. 9530, 1974 - Halsey). [Additional Reference(s): DWR Levee Log, 2002. USACE Sacramento O&M Manual 136, March 1960 (HLM 6.61)]. FS Date: 4/26/2017 1:50:06 PM

Waterside view: CMP riser with slide gate

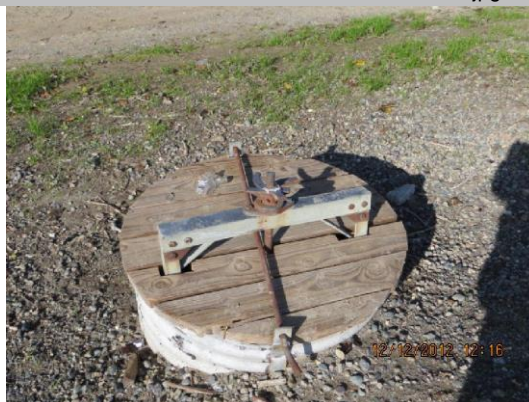
Photo 2 of 3 : UCIP_SP_2017_51694_47188.jpg

Comment Code					
Inspector Comment					
FS_ID:51694 DS_ID:17300 EP_NO: N/A Repair Type: Non-Urgent Crossing Status: Indicator Found UCIP Comments: 4/19/2017 Abandoned- needs to be done properly. (DWR Sutter Yard- AFreitag)10/31/2016 Abandoned (DWR Sutter Yard- AFreitag)6/1/2016 Abandoned4/1/2015 Only cmp riser and slide gate found on WS.Abandoned riser with slide gate on WS. Abandoned concrete surge box on WS. Verify pipe has been abandoned properly. 6/30/2014 Same as last inspection.12/18/2013 Same as last inspection.7/23/2013 Same as last inspection. FIELD_STRUCT_DESC: *ABANDONED* 24-inch corrugated metal drainage pipe through the levee, 14.5 feet below the crown, not found in 2015. Slide gate in a concrete surge box on the waterside (WS) berm, found in 2015. Slide gate in a corrugated metal pipe (CMP) riser, found in 2015. Pump on the WS slope, not found in 2015. [Additional Reference(s): DWR Levee Log, 2002. USACE Sacramento O&M Manual 136, March 1960 (HLM 7.61)]. FS Date: 4/26/2017 2:37:43 PM

Waterside view: CMP riser with slide gate

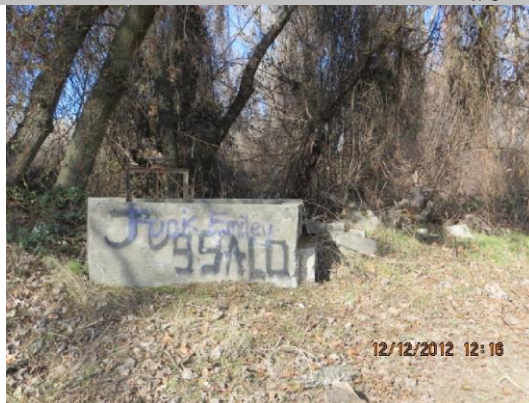
Photo 3 of 3 : UCIP_SP_2017_51694_47192.jpg

Item	DWR UCIP Field Study			39.238153 °	39.238153 °	
				-121.995024 °	-121.995024 °	
DWR ID						
Comment Code						
Inspector Comment						
FS_ID:51694 DS_ID:17300 EP_NO: N/A Repair Type: Non-Urgent Crossing Status: Indicator Found UCIP Comments: 4/19/2017 Abandoned- needs to be done properly. (DWR Sutter Yard- AFreitag)10/31/2016 Abandoned (DWR Sutter Yard- AFreitag)6/1/2016 Abandoned4/1/2015 Only cmp riser and slide gate found on WS.Abandoned riser with slide gate on WS. Abandoned concrete surge box on WS. Verify pipe has been abandoned properly. 6/30/2014 Same as last inspection.12/18/2013 Same as last inspection.7/23/2013 Same as last inspection. FIELD_STRUCT_DESC: *ABANDONED* 24-inch corrugated metal drainage pipe through the levee, 14.5 feet below the crown, not found in 2015. Slide gate in a concrete surge box on the waterside (WS) berm, found in 2015. Slide gate in a corrugated metal pipe (CMP) riser, found in 2015. Pump on the WS slope, not found in 2015. [Additional Reference(s): DWR Levee Log, 2002. USACE Sacramento O&M Manual 136, March 1960 (HLM 7.61)]. FS Date: 4/26/2017 2:37:43 PM

Waterside view: abandoned concrete surge box

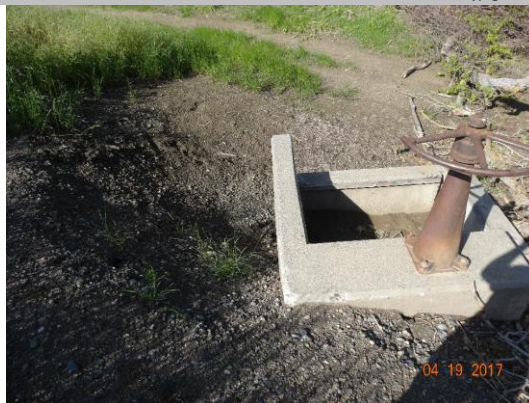
Photo 1 of 3 : UCIP_SP_2017_51695_77008.jpg

FS_ID:51695
DS_ID:17301
EP_NO: 9532
Repair Type: Non-Urgent
Crossing Status: Found
UCIP Comments: 4/19/2017 Abandoned- erosion/depression present around the WS box (DWR Sutter Yard- AFreitag)10/31/2016 Abandoned and erosion still present near WS box.(DWR Sutter Yard- AFreitag)6/1/2016 Appears to be an abandoned crossing.4/1/2015 Silted concrete box on WS. Depression/erosion around concrete box on WS.Silted concrete box on WS. Depression/erosion around concrete box on WS.6/30/2014 Same as last inspection.12/18/2013 Same as last inspection.7/23/2013 Same as last inspection.
FIELD_STRUCT_DESC: *ABANDONED* 36-inch by 48-inch reinforced concrete box drainage culvert through the levee, 11.6 feet below the crown. Slide gate in a concrete box on the waterside (WS) slope. (Automatic Board Order (ABO) issued as Permit No. 9532, 1974 - Martin). [Additional Reference(s): DWR Levee Log, 2002. USACE Sacramento O&M Manual 136, March 1960 (HLM 7.73)].

LM Start	7.72	Rating **	M	Issue No.	156 (cont)
LM End	7.72	Issue Type +	Ma	Location *	WS

Depression around WS concrete box

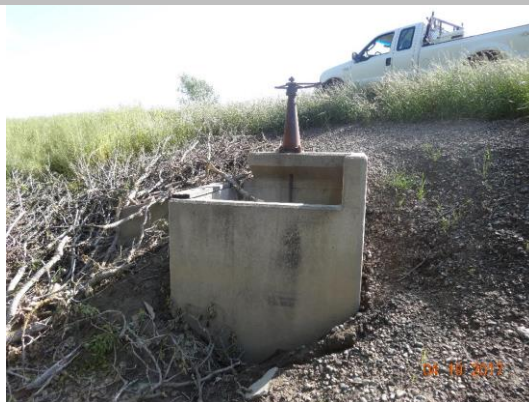
Photo 2 of 3 : UCIP_SP_2017_51695_77009.jpg

depression around WS concrete box

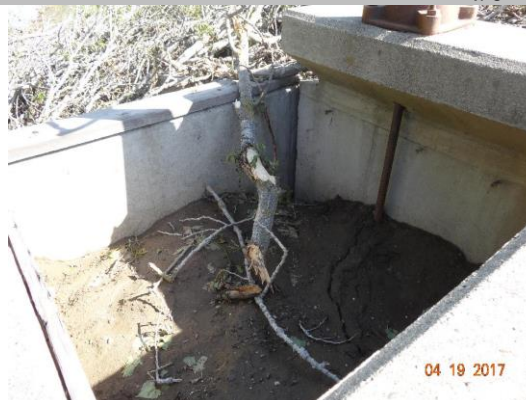
Photo 3 of 3 : UCIP_SP_2017_51695_77010.jpg

Item	DWR UCIP LMA Responsibility			39.239458 °	39.239458 °	
				-121.993398 °	-121.993398 °	
DWR ID						
Comment Code						
Inspector Comment						
FS_ID:51695 DS_ID:17301 EP_NO: 9532 Repair Type: Non-Urgent Crossing Status: Found UCIP Comments: 4/19/2017 Abandoned- erosion/depression present around the WS box (DWR Sutter Yard- AFreitag)10/31/2016 Abandoned and erosion still present near WS box.(DWR Sutter Yard-Afreitag)6/1/2016 Appears to be an abandoned crossing.4/1/2015 Silted concrete box on WS. Depression/erosion around concrete box on WS.Silted concrete box on WS. Depression/erosion around concrete box on WS.6/30/2014 Same as last inspection.12/18/2013 Same as last inspection.7/23/2013 Same as last inspection. FIELD_STRUCT_DESC: *ABANDONED* 36-inch by 48-inch reinforced concrete box drainage culvert through the levee, 11.6 feet below the crown. Slide gate in a concrete box on the waterside (WS) slope. (Automatic Board Order (ABO) issued as Permit No. 9532, 1974 - Martin). [Additional Reference(s): DWR Levee Log, 2002. USACE Sacramento O&M Manual 136, March 1960 (HLM 7.73)]. FS Date: 4/26/2017 2:38:29 PM

WS concrete box full of silt.

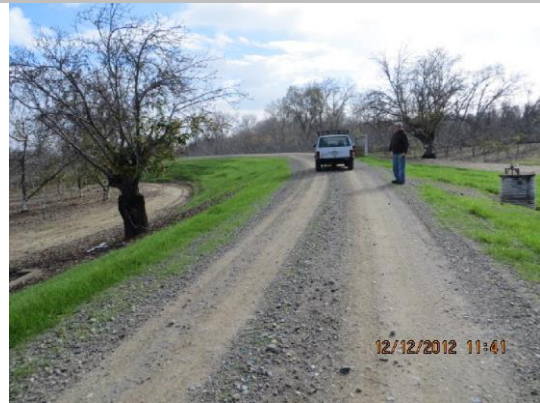
Photo 1 of 3 : UCIP_SP_2017_51698_47202.jpg

Comment Code					
Inspector Comment					
FS_ID:51698 DS_ID:17304 EP_NO: 9529 Repair Type: Non-Urgent Crossing Status: Found UCIP Comments: 4/19/2017 Abandoned- needs to be done properly. (DWR Sutter Yard- AFreitag)10/31/2016 Abandoned (DWR Sutter Yard- AFreitag)6/1/2016 Abandoned- only WS riser and slide gate found.4/1/2015 CMP riser and slide gate on WS. LS distribution box is silted in. Looks abandoned. CMP riser with slide gate on WS. Concrete distribution box on LS- full with silt.6/30/2014 Same as last inspection.12/18/2013 Same as last inspection.7/23/2013 Same as last inspection. FIELD_STRUCT_DESC: *ABANDONED* 24-inch corrugated metal drainage pipe through the levee, invert 12.8 feet below the crown. Slide gate in a corrugated metal pipe (CMP) riser on the waterside (WS) slope. Concrete box at the landside (LS) toe. (Automatic Board Order (ABO) issued as Permit No. 9529, 1974 - Dorwood Ranching Company). [Additional Reference(s): DWR Levee Log, 2002. USACE Sacramento O&M Manual 136, March 1960 (HLM 8.35)]. FS Date: 4/26/2017 2:54:54 PM

Crown view: overview (both sides of the levee)

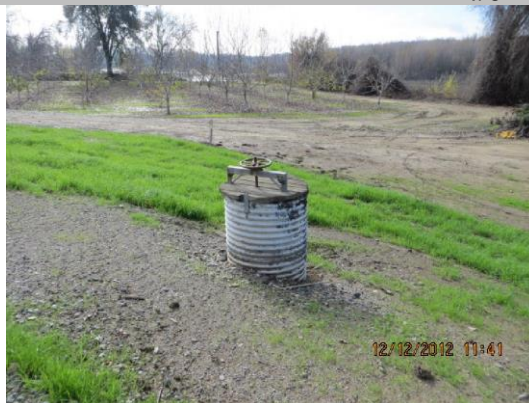
Photo 2 of 3 : UCIP_SP_2017_51698_47201.jpg

Item	DWR UCIP LMA Responsibility			39.246317 °		39.246317 °
				-121.998825 °		-121.998825 °
DWR ID						
Comment Code						
Inspector Comment						
FS_ID:51698 DS_ID:17304 EP_NO: 9529 Repair Type: Non-Urgent Crossing Status: Found UCIP Comments: 4/19/2017 Abandoned- needs to be done properly. (DWR Sutter Yard- AFreitag)10/31/2016 Abandoned (DWR Sutter Yard- AFreitag)6/1/2016 Abandoned- only WS riser and slide gate found.4/1/2015 CMP riser and slide gate on WS. LS distribution box is silted in. Looks abandoned. CMP riser with slide gate on WS. Concrete distribution box on LS- full with silt.6/30/2014 Same as last inspection.12/18/2013 Same as last inspection.7/23/2013 Same as last inspection. FIELD_STRUCT_DESC: *ABANDONED* 24-inch corrugated metal drainage pipe through the levee, invert 12.8 feet below the crown. Slide gate in a corrugated metal pipe (CMP) riser on the waterside (WS) slope. Concrete box at the landside (LS) toe. (Automatic Board Order (ABO) issued as Permit No. 9529, 1974 - Dorwood Ranching Company). [Additional Reference(s): DWR Levee Log, 2002. USACE Sacramento O&M Manual 136, March 1960 (HLM 8.35)]. FS Date: 4/26/2017 2:54:54 PM

Waterside view: overview of CMP riser

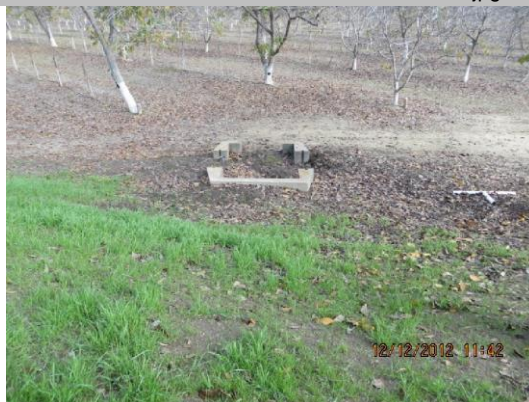
Photo 3 of 3 : UCIP_SP_2017_51698_47200.jpg

LM Start	8.32	Rating **	M	Issue No.	157 (cont)
LM End	8.32	Issue Type +	Ma	Location *	LS

Landside view: overview of concrete box

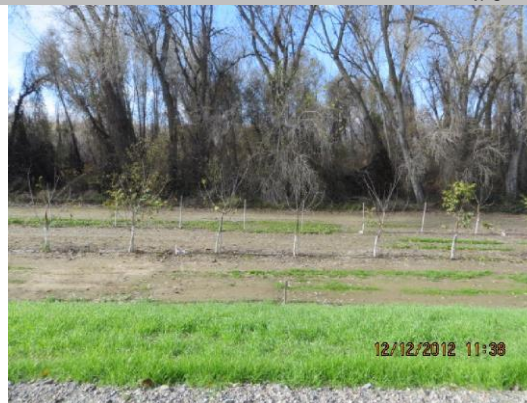
Photo 3 of 3 : UCIP_SP_2017_51724_47204.jpg

Item	DWR UCIP Field Study			39.247098 °		39.247098 °
				-121.999055 °		-121.999055 °
DWR ID						
Comment Code						
Inspector Comment						
FS_ID:51724 DS_ID:17338 EP_NO: N/A Repair Type: Non-Urgent Crossing Status: Indicator Found UCIP Comments: 4/19/2017 Still only LS airvent found. (DWR Sutter Yard- Afreitag)10/31/2016 Only the LS standpipe and airvent found.6/1/2016 Still only the vaccum breaker on LS shoulder visible.4/1/2015 Only vacuum breaker found on LS shoulder.6/30/2014 Same as last inspection.12/18/2013 Same as last inspection.7/23/2013 Same as last inspection. FIELD_STRUCT_DESC: Pipe of unknown diameter, purpose and material through the levee, at an unknown depth below the crown, not found. Vacuum breaker inside steel standpipe on the landside (LS) shoulder, found in 2015. [Additional Reference(s): DWR Levee Log, 2002]. FS Date: 5/1/2017 8:31:33 AM

Landside view: overview (no pipes)

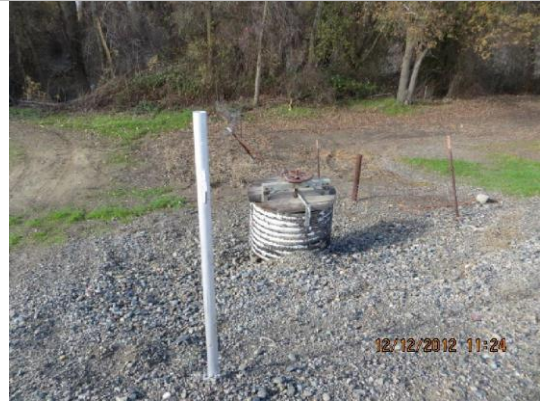
Photo 1 of 3 : UCIP_SP_2017_51725_47208.jpg

FS_ID:51725
DS_ID:17295
EP_NO: 9529
Repair Type: No Action Needed
Crossing Status: Found
UCIP Comments: 4/19/2017 Abandoned- needs to be done so properly. (DWR Sutter Yard- Afreitag)10/31/2016 Abandoned. (DWR Sutter Yard- Afreitag)6/13/2016 Pipe was exposed and camera inspected by Nor-Cal Pipeline Services 10/29/2015. Photos of the exposed pipe ends were uploaded on 4/1/2015. The internal inspection showed some signs of rust but no visible holes or deterioration were found. After the inspection the pipe ends were capped and reburied.6/9/2016 Khalida Fazel of UCIP requests that any photos of the pipe when it was exposed for a video inspection be kindly uploaded here.4/4/2016 Proper abandonment of pipe is needed. Pipe has been buried again after it was dug up and video inspected, so was not visible on LS. Note that landowner has regraded LS slope so drainage is now to the east (toward LS).4/1/2015 Both WS and LS pipe ends have been dug up in preparation for an internal camera inspection. Pipe shows signs of heavy rust and both ends of pipe are plugged with soil.Only a CMP riser with slide gate found on WS.6/30/2014 Same as last inspection.12/18/2013 Same as last inspection.7/23/2013 Same as last inspection.

Waterside view: overview of CMP riser

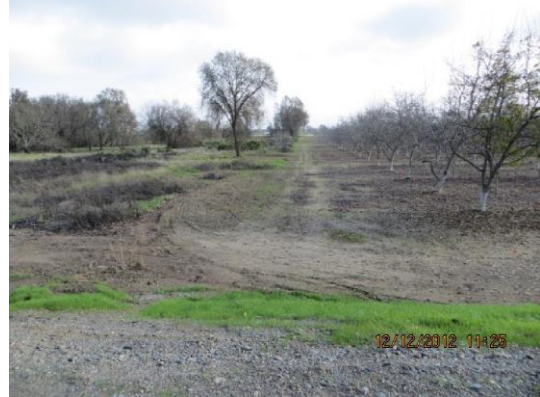
Photo 2 of 3 : UCIP_SP_2017_51725_47207.jpg

Landside view: overview (no pipes)

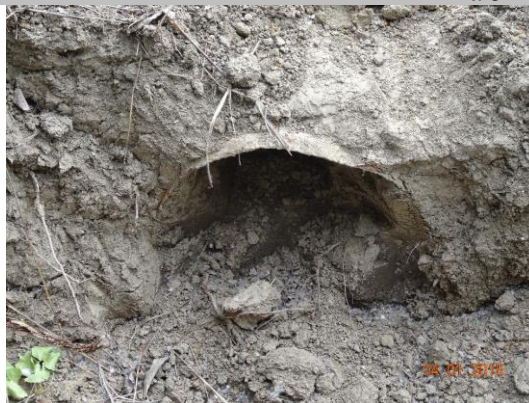
Photo 3 of 3 : UCIP_SP_2017_51725_73640.jpg

Comment Code					
Inspector Comment					
FS_ID:51725 DS_ID:17295 EP_NO: 9529 Repair Type: No Action Needed Crossing Status: Found UCIP Comments: 4/19/2017 Abandoned- needs to be done so properly. (DWR Sutter Yard- Afreitag)10/31/2016 Abandoned. (DWR Sutter Yard- Afreitag)6/13/2016 Pipe was exposed and camera inspected by Nor-Cal Pipeline Services 10/29/2015. Photos of the exposed pipe ends were uploaded on 4/1/2015. The internal inspection showed some signs of rust but no visible holes or deterioration were found. After the inspection the pipe ends were capped and reburied.6/9/2016 Khalida Fazel of UCIP requests that any photos of the pipe when it was exposed for a video inspection be kindly uploaded here.4/4/2016 Proper abandonment of pipe is needed. Pipe has been buried again after it was dug up and video inspected, so was not visible on LS. Note that landowner has regraded LS slope so drainage is now to the east (toward LS).4/1/2015 Both WS and LS pipe ends have been dug up in preparation for an internal camera inspection. Pipe shows signs of heavy rust and both ends of pipe are plugged with soil.Only a CMP riser with slide gate found on WS.6/30/2014 Same as last inspection.12/18/2013 Same as last inspection.7/23/2013 Same as last inspection. FIELD_STRUCT_DESC: *ABANDONED* 24-inch irrigation and drainage pipe through the levee, invert 11.5 feet below the crown. Slide gate in a corrugated metal pipe (CMP) riser on the waterside (WS) slope. (Automatic Board Order (ABO) issued as Permit No. 9529, 1974 - Dorwood Ranching Co.) [Additional Reference(s): DWR Levee Log, 2002. USACE Sacramento O&M Manual 136, March 1960 (HLM 8.55)] FS Date: 5/1/2017 8:37:22 AM

WS pipe end

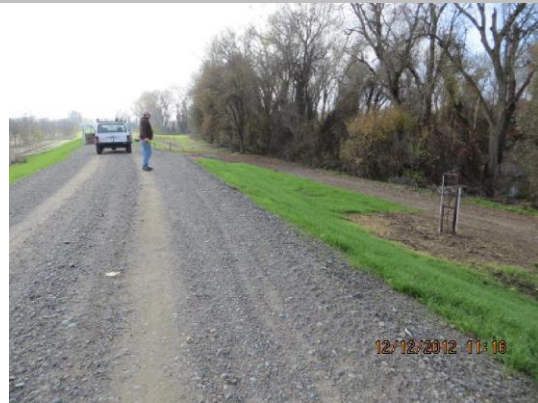
Photo 1 of 3 : UCIP_SP_2017_51726_47210.jpg

FS_ID:51726
DS_ID:17327
EP_NO: 9528
Repair Type: Non-Urgent
Crossing Status: Found
UCIP Comments: 4/19/2017 Abandoned- needs to be done so properly. (DWR Sutter Yard- Afreitag)10/31/2016 Abandoned. (DWR Sutter Yard- Afreitag)6/13/2016 Pipe was internally cleaned and camera inspected by Nor-Cal Pipeline Services on 10/29/2015. Pipe length through levee is 75.1ft long. The inspection showed some signs of rust but no holes or other deterioration were found. Pics of exposed pipe ends were uploaded on 4/1/2015. After the inspection the pipe ends were capped and reburied.4/14/2016- Same as last inspection.4/1/2015- Both ends of pipe have been dug up in preparation for internal camera inspections. Pipe shows some rust but appears to be in decent shape. Only buried slide gate structure found.6/30/2014- Same as last inspection.12/18/2013 Same as last inspection.7/23/2013 Same as last inspection.
FIELD_STRUCT_DESC: *ABANDONED* 24-inch corrugated metal drainage pipe through the levee, 12.5 feet below the crown. Slide gate on the waterside (WS). (Automatic Board Order (ABO) issued as Permit No. 9528, 1974 - Lamb). [Additional Reference(s): DWR Levee Log, 2002. USACE Sacramento O&M Manual 136, March 1960 (HLM 8.59)].

Waterside view: overview

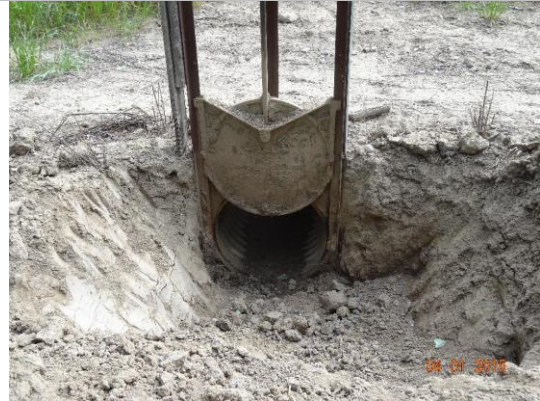
Photo 3 of 3 : UCIP_SP_2017_51726_73649.jpg

Item	DWR UCIP LMA Responsibility			39.249678 °	39.249678 °	
				-121.999021 °	-121.999021 °	
DWR ID						
Comment Code						
Inspector Comment						
FS_ID:51726 DS_ID:17327 EP_NO: 9528 Repair Type: Non-Urgent Crossing Status: Found UCIP Comments: 4/19/2017 Abandoned- needs to be done so properly. (DWR Sutter Yard- Afreitag)10/31/2016 Abandoned. (DWR Sutter Yard- Afreitag)6/13/2016 Pipe was internally cleaned and camera inspected by Nor-Cal Pipeline Services on 10/29/2015. Pipe length through levee is 75.1ft long. The inspection showed some signs of rust but no holes or other deterioration were found. Pics of exposed pipe ends were uploaded on 4/1/2015. After the inspection the pipe ends were capped and reburied.4/14/2016- Same as last inspection.4/1/2015- Both ends of pipe have been dug up in preparation for internal camera inspections. Pipe shows some rust but appears to be in decent shape. Only buried slide gate structure found.6/30/2014- Same as last inspection.12/18/2013 Same as last inspection.7/23/2013 Same as last inspection. FIELD_STRUCT_DESC: *ABANDONED* 24-inch corrugated metal drainage pipe through the levee, 12.5 feet below the crown. Slide gate on the waterside (WS). (Automatic Board Order (ABO) issued as Permit No. 9528, 1974 - Lamb). [Additional Reference(s): DWR Levee Log, 2002. USACE Sacramento O&M Manual 136, March 1960 (HLM 8.59)]. FS Date: 5/1/2017 8:51:02 AM

WS pipe end

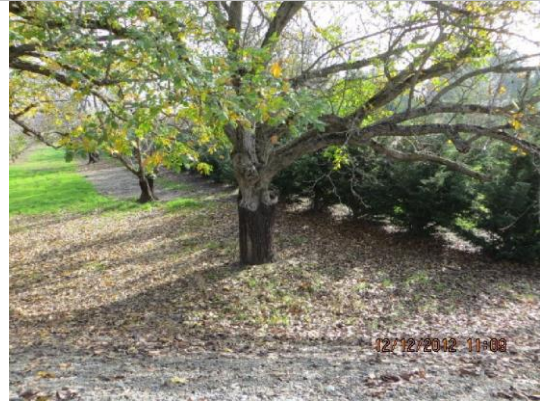
Photo 1 of 3 : UCIP_SP_2017_51728_74662.jpg

FS_ID:51728
DS_ID:17352
EP_NO: 9523
Repair Type: Non-Urgent
Crossing Status: Indicator Found
UCIP Comments: 4/19/2017 Abandoned- needs to be done so properly. (DWR Sutter Yard- Afreitag)10/31/2016 Abandoned. (DWR Sutter Yard- Afreitag)6/13/2016 Abandoned crossing.4/14/2016 Appears abandoned and if so, should be done so properly. Borrowing activity on landside (LS).8/28/2015 Pipe has been dug up and located along the WS levee toe.6/30/2014 Unable to locate.12/18/2013 Unable to locate.7/23/2013 Same as last inspection. Unable to locate.
FIELD_STRUCT_DESC: *ABANDONED* 10-inch concrete encased steel drainage pipe through the levee, invert 15 feet below the crown, not found in 2016. Gate valve in a 42-inch corrugated metal pipe riser on the waterside (WS) slope, found in 2016. (Automatic Board Order (ABO) issued as Permit No. 9523, 1974 - Blackmore). Additional Reference(s): DWR Levee Log, 2002. USACE Sacramento O&M Manual 136, March 1960 (HLM 8.7)].

View of LS

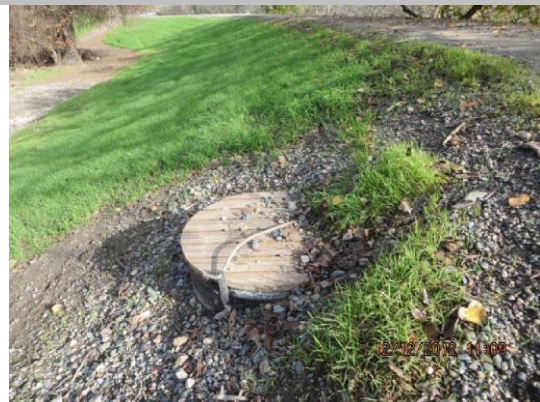
Photo 2 of 3 : UCIP_SP_2017_51728_74661.jpg

42-inch riser on WS shoulder.

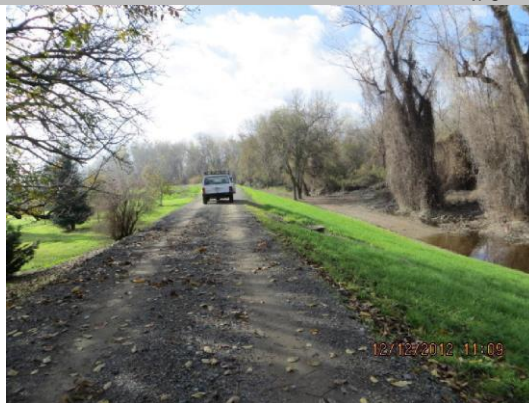
Photo 3 of 3 : UCIP_SP_2017_51728_74660.jpg

Comment Code					
Inspector Comment					
FS_ID:51728 DS_ID:17352 EP_NO: 9523 Repair Type: Non-Urgent Crossing Status: Indicator Found UCIP Comments: 4/19/2017 Abandoned- needs to be done so properly. (DWR Sutter Yard- Afreitag)10/31/2016 Abandoned. (DWR Sutter Yard- Afreitag)6/13/2016 Abandoned crossing.4/14/2016 Appears abandoned and if so, should be done so properly. Borrowing activity on landside (LS).8/28/2015 Pipe has been dug up and located along the WS levee toe.6/30/2014 Unable to locate.12/18/2013 Unable to locate.7/23/2013 Same as last inspection. Unable to locate. FIELD_STRUCT_DESC: *ABANDONED* 10-inch concrete encased steel drainage pipe through the levee, invert 15 feet below the crown, not found in 2016. Gate valve in a 42-inch corrugated metal pipe riser on the waterside (WS) slope, found in 2016. (Automatic Board Order (ABO) issued as Permit No. 9523, 1974 - Blackmore). Additional Reference(s): DWR Levee Log, 2002. USACE Sacramento O&M Manual 136, March 1960 (HLM 8.7)]. FS Date: 5/1/2017 8:59:37 AM

View from crown of levee looking downstream.

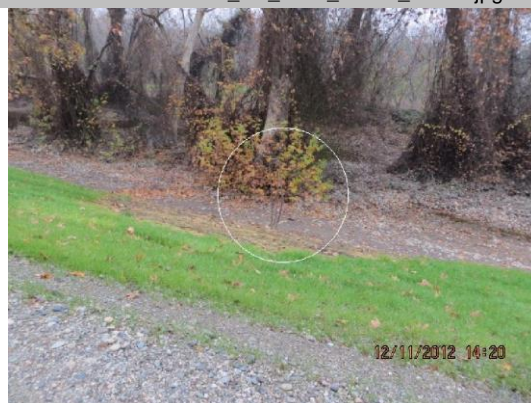
Photo 1 of 3 : UCIP_SP_2017_51729_47216.jpg

FS_ID:51729
DS_ID:17353
EP_NO: 4491
Repair Type: Urgent
Crossing Status: Found
UCIP Comments: 4/19/2017 4in. pipe still showing signs of deterioration near WS toe. (DWR Sutter Yard- Afreitag)10/31/2016 Pipe still exposed along the WS toe and is rusted and corroded. If it is still in use by the owner then it should be rebuilt.(DWR Sutter Yard-Afreitag)6/13/2016 Pipe was dug up on WS and photographed. It was originally selected for internal inspection but was unable to be as there was no access to the inside of the 4" pipe. (DWR Sutter Yard -afreitag)4/14/2016 Signs of corrosion on pipe and valve on LS. Pipe in use according to Bryan Reniff of Sutter Yard. (DWR UCIP -kfazel)8/28/2015 Pipe was dug up and located on the WS levee toe. (DWR Sutter Yard - afreitag)6/30/2014 Same as last inspection. (DWR Sutter Yard - afreitag)12/18/2013 Same as last inspection. (DWR Sutter Yard - afreitag)7/23/2013 Same as last inspection. (DWR Sutter Yard - afreitag)12/11/2012 Only abandoned slide gate found on WS. (DWR UCIP - pamatya)

Waterside view: overview of slide gate on steel structure (belongs to crossing at CLM-8.782)

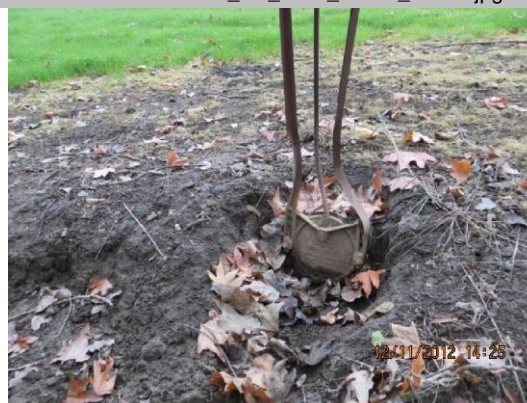
Photo 2 of 3 : UCIP_SP_2017_51729_47215.jpg

UCIP Comments: 4/19/2017 4in. pipe still showing signs of deterioration near WS toe. (DWR Sutter Yard- Afreitag)10/31/2016 Pipe still exposed along the WS toe and is rusted and corroded. If it is still in use by the owner then it should be rebuilt.(DWR Sutter Yard-Afreitag)6/13/2016 Pipe was dug up on WS and photographed. It was originally selected for internal inspection but was unable to be as there was no access to the inside of the 4" pipe. (DWR Sutter Yard - afreitag)4/14/2016 Signs of corrosion on pipe and valve on LS. Pipe in use according to Bryan Reniff of Sutter Yard. (DWR UCIP - kfazel)8/28/2015 Pipe was dug up and located on the WS levee toe. (DWR Sutter Yard - afreitag)6/30/2014 Same as last inspection. (DWR Sutter Yard - afreitag)12/18/2013 Same as last inspection. (DWR Sutter Yard - afreitag)7/23/2013 Same as last inspection. (DWR Sutter Yard - afreitag)12/11/2012 Only abandoned slide gate found on WS. (DWR UCIP - pamatya)

Waterside view: slide gate on steel structure (belongs to crossing at CLM-8.782)

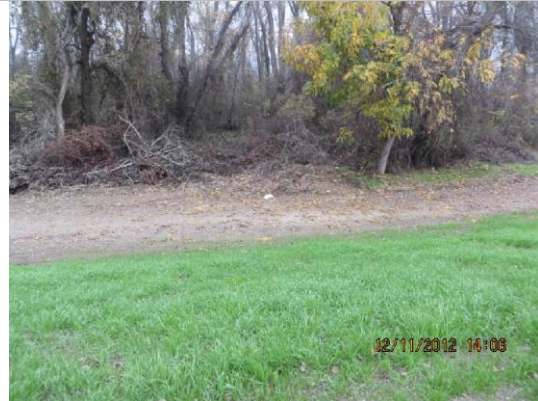
Photo 1 of 3 : UCIP_SP_2017_51731_47242.jpg

FS_ID:51731
DS_ID:17355
EP_NO: N/A
Repair Type: No Action Needed
Crossing Status: Found
UCIP Comments: 4/19/2017 Abandoned- needs to be done so properly. (DWR Sutter Yard- Afreitag)10/31/2016 Abandoned. (DWR Sutter Yard- Afreitag)6/13/2016 Pipe was internally cleaned and camera inspected on 10/30/2015 by Nor-Cal Pipeline Services. WS cap was removed and 100.6ft of pipe were inspected starting from the WS opening. Inspection revealed rusting but no visible holes or other deterioration were found. Pipe was recapped after the inspection. This pipe is always visible so no new photos were taken during the inspection.6/9/2016 Khalida Fazel of UCIP requests that any photos of the pipe when it was exposed for a video inspection be kindly uploaded here.4/1/2015 Pipe is in same condition. It has been selected for an internal camera inspection. New CMP pipe on WS capped with steel plate.6/30/2014 Same as last inspection.12/18/2013 Same as last inspection.7/23/2013 Same as last inspection.

Waterside view: overview

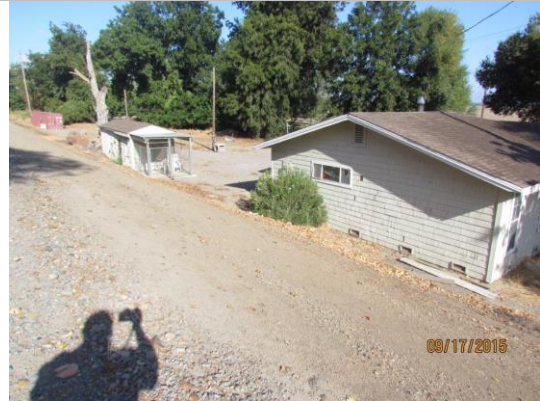
Photo 1 of 1 : SP_2017_ST0003_264_4_20170315_00004.jpg

LM Start	10.27	Rating **	M	Issue No.	4
LM End	10.27	Issue Type +	En	Location *	LS
Category	Earthen Levee			GPS Latitude/Longitude	
				Start	End
Item	Encroachments			39.270431 °	39.270431 °
				-121.999782 °	-121.999782 °
DWR ID	DWR_ST0003_01_s_2012_4				
Comment Code					
BU : Building					
Inspector Comment

View of the house and dog kennel at the landside toe.

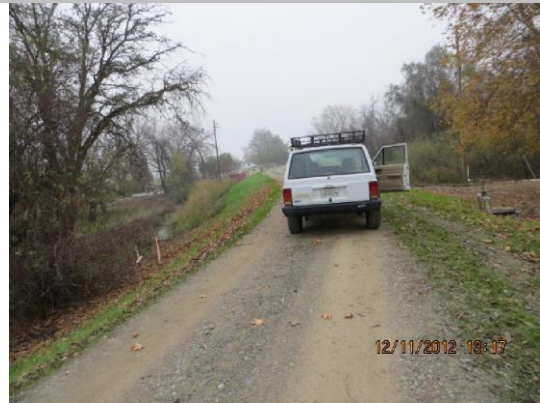
Photo 1 of 3 : UCIP_SP_2017_51734_47263.jpg

Comment Code					
Inspector Comment					
FS_ID:51734 DS_ID:17358 EP_NO: 9517 Repair Type: No Action Needed Crossing Status: Found UCIP Comments: 4/19/2017 No WS end found/ slide gate handle broken. (DWR Sutter Yard- Afreitag)10/31/2016 Slide gate handle is broken and no WS pipe end can be located. (DWR Sutter Yard- Afreitag)6/1/2016 WS slide gate handle is still broken. No WS pipe end was found.4/1/2015 Slide gate handle is still broken. The rest of the pipe appears in good condition. Broken slide gate handle found on WS.6/30/2014 Same as last inspection.12/18/2013 Same as last inspection.7/23/2013 Same as last inspection. FIELD_STRUCT_DESC: 48-inch corrugated metal drainage pipe through the levee, 14 feet below the crown. Slide gate in a 60-inch corrugated metal pipe (CMP) riser on the waterside (WS) slope. Slide gate in a concrete distribution box on the landside (LS) toe. (Automatic Board Order (ABO) issued as Permit No. 9517, 1974 - Griffin). [Additional Reference(s): DWR Levee Log, 2002. USACE Sacramento O&M Manual 136, March 1960 (HLM 10.47)]. FS Date: 5/1/2017 9:32:45 AM

Crown view: overview (both sides of the levee)

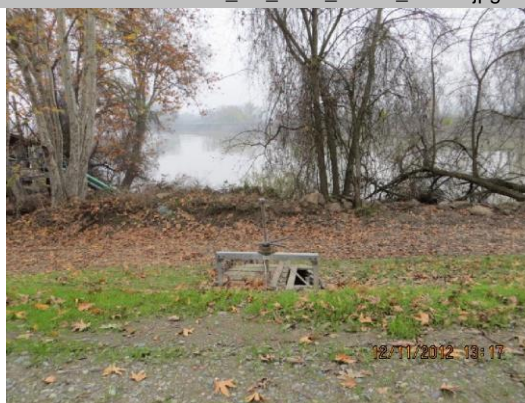
Photo 2 of 3 : UCIP_SP_2017_51734_47262.jpg

Item	DWR UCIP LMA Responsibility			39.270492 °	39.270492 °	
				-122.001306 °	-122.001306 °	
DWR ID						
Comment Code						
Inspector Comment						
FS_ID:51734						
DS_ID:17358						
EP_NO: 9517						
Repair Type: No Action Needed						
Crossing Status: Found						
UCIP Comments: 4/19/2017 No WS end found/ slide gate handle broken. (DWR Sutter Yard- Afreitag)10/31/2016 Slide gate handle is broken and no WS pipe end can be located. (DWR Sutter Yard- Afreitag)6/1/2016 WS slide gate handle is still broken. No WS pipe end was found.4/1/2015 Slide gate handle is still broken. The rest of the pipe appears in good condition. Broken slide gate handle found on WS.6/30/2014 Same as last inspection.12/18/2013 Same as last inspection.7/23/2013 Same as last inspection.						
FIELD_STRUCT_DESC: 48-inch corrugated metal drainage pipe through the levee, 14 feet below the crown. Slide gate in a 60-inch corrugated metal pipe (CMP) riser on the waterside (WS) slope. Slide gate in a concrete distribution box on the landside (LS) toe. (Automatic Board Order (ABO) issued as Permit No. 9517, 1974 - Griffin).

Waterside view: overview of CMP riser

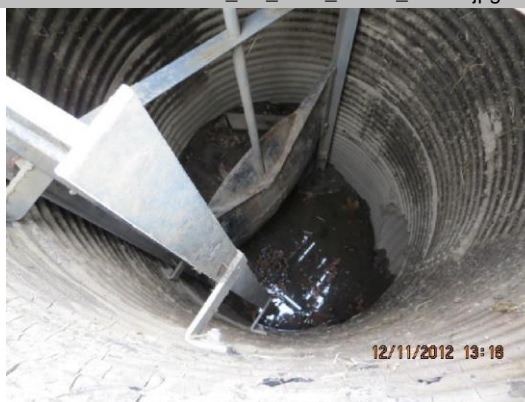
Photo 3 of 3 : UCIP_SP_2017_51734_47268.jpg

Waterside view: inside CMP riser

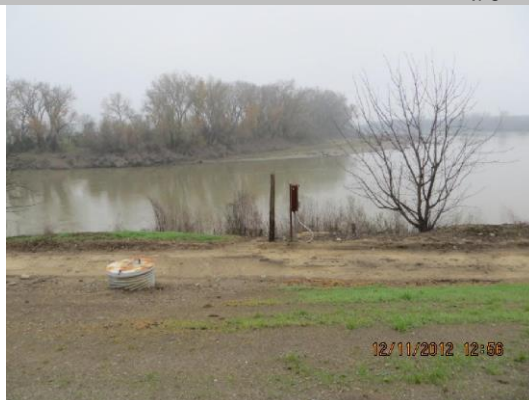
Photo 1 of 3 : UCIP_SP_2017_51735_47270.jpg

Comment Code					
Inspector Comment					
FS_ID:51735 DS_ID:17371 EP_NO: 9517 Repair Type: Non-Urgent Crossing Status: Found UCIP Comments: 4/19/2017 Abandoned- needs to be done so properly. (DWR Sutter Yard- Afreitag)10/31/2016 Abandoned. (DWR Sutter Yard- Afreitag)6/1/2016 Abandoned crossing.4/2/2015 Same as last inspection. Need to verify type of abandonment. Pump house not found on waterside of the levee. Looks abandoned as switch panel found without pump.6/30/2014 Same as last inspection.12/18/2013 Same as last inspection.7/23/2013 Same as last inspection. FIELD_STRUCT_DESC: *ABANDONED* 18-inch steel irrigation pipe through the levee, 17.1 feet below the crown. Gate valve and flap gate in a concrete distribution box. Water meter in a corrugated metal pipe (CMP) riser at the landside (LS) toe. Gate valve in a CMP on the waterside (WS). Pipe was replaced in November 2005. (Automatic Board Order (ABO) issued as Permit No. 9517, 1974 - Griffin). [Additional Reference(s): DWR Levee Log, 2002. USACE Sacramento O&M Manual 136, March 1960 (HLM 10.53)]. FS Date: 5/1/2017 9:39:39 AM

Waterside view: CMP riser and abandoned service pole

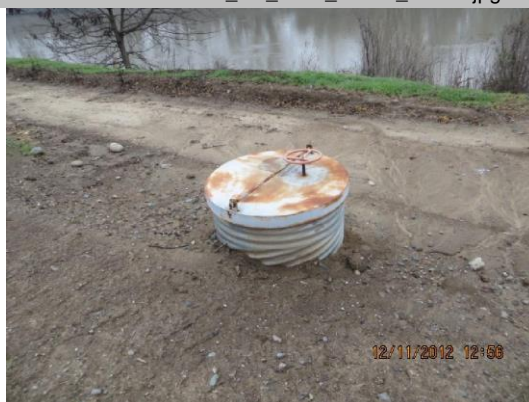
Photo 2 of 3 : UCIP_SP_2017_51735_47269.jpg

Waterside view: CMP riser with gate valve

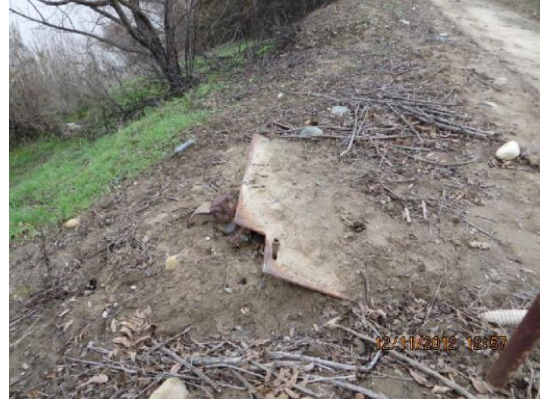
Photo 3 of 3 : UCIP_SP_2017_51735_47273.jpg

Item	DWR UCIP Field Study			39.271928 °	39.271928 °	
				-122.003422 °	-122.003422 °	
DWR ID						
Comment Code						
Inspector Comment						
FS_ID:51735 DS_ID:17371 EP_NO: 9517 Repair Type: Non-Urgent Crossing Status: Found UCIP Comments: 4/19/2017 Abandoned- needs to be done so properly. (DWR Sutter Yard- Afreitag)10/31/2016 Abandoned. (DWR Sutter Yard- Afreitag)6/1/2016 Abandoned crossing.4/2/2015 Same as last inspection. Need to verify type of abandonment. Pump house not found on waterside of the levee. Looks abandoned as switch panel found without pump.6/30/2014 Same as last inspection.12/18/2013 Same as last inspection.7/23/2013 Same as last inspection. FIELD_STRUCT_DESC: *ABANDONED* 18-inch steel irrigation pipe through the levee, 17.1 feet below the crown. Gate valve and flap gate in a concrete distribution box. Water meter in a corrugated metal pipe (CMP) riser at the landside (LS) toe. Gate valve in a CMP on the waterside (WS). Pipe was replaced in November 2005. (Automatic Board Order (ABO) issued as Permit No. 9517, 1974 - Griffin). [Additional Reference(s): DWR Levee Log, 2002. USACE Sacramento O&M Manual 136, March 1960 (HLM 10.53)]. FS Date: 5/1/2017 9:39:39 AM

Waterside view: abandoned pump station.

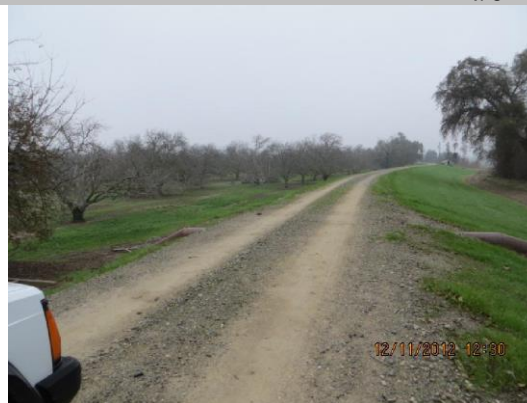
Photo 1 of 3 : UCIP_SP_2017_51737_47284.jpg

FS_ID:51737
DS_ID:17350
EP_NO: 1369
Repair Type: Non-Urgent
Crossing Status: Found
UCIP Comments: 4/19/2017 Abandoned- needs to be done so properly. (DWR Sutter Yard- Afreitag)10/31/2016 Appears abandoned. (DWR Sutter Yard- Afreitag)6/1/2016 Appears to be an abandoned crossing.4/2/2015 Same as last inspection. Looks abandoned and if so should be done so properly. Pump and switch panel not found. Outlet pipe blocked by silt and debris.6/30/2014 Same as last inspection.12/18/2013 Same as last inspection.7/23/2013 Same as last inspection.
FIELD_STRUCT_DESC: *ABANDONED* 24-inch steel irrigation pipe through the levee, 4 feet below the crown. Siphon breaker on the landside (LS) slope. Concrete distribution box on the LS toe. (Permit No. 1369, 1949 - Griffin). [Additional Reference(s): DWR Levee Log, 2002. USACE Sacramento O&M Manual 136, March 1960 (HLM 10.68)].
FS Date: 5/1/2017 9:44:43 AM

Crown view: overview (both sides of the levee)

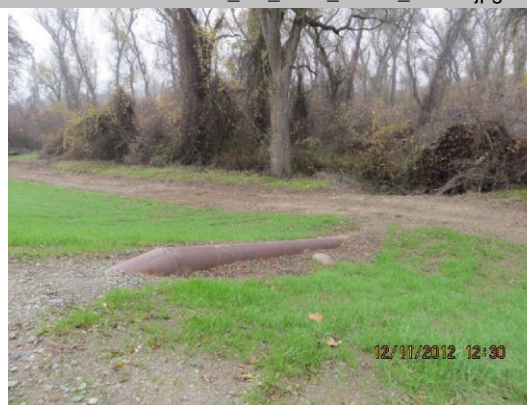
Photo 2 of 3 : UCIP_SP_2017_51737_47283.jpg

Waterside view: overview of exposed steel pipe

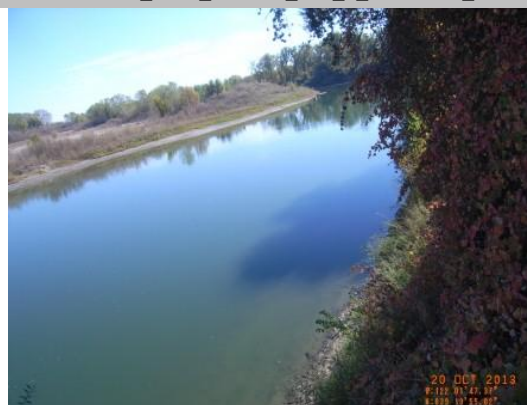
Waterway	Bank	Unit Miles	Inspection Start/End	Inspector
Unit No. 01 Sacramento River	Left	19.85	03/22/2017 03/22/2017	Bob Duffey

Sutter Maintenance Yard East Levee Sacramento River

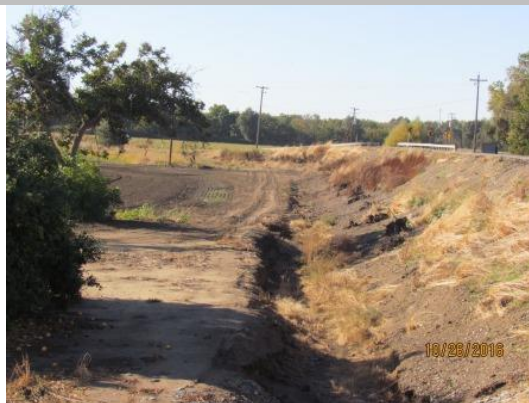
Photo 1 of 1 : SP_2017_ST0003_264_7_20170315_00006.jpg

LM Start	11.94	Rating **	M	Issue No.	7
LM End	12.18	Issue Type +	En	Location *	LS
Category	Earthen Levee			GPS Latitude/Longitude	
				Start	End
Item	Encroachments			39.285658 °	39.288978 °
				-122.014574 °	-122.013892 °
DWR ID	DWR_ST0003_01_s_2012_7				
Comment Code					
DT : Ditch					
Inspector Comment

View of the ditch along the landside toe.

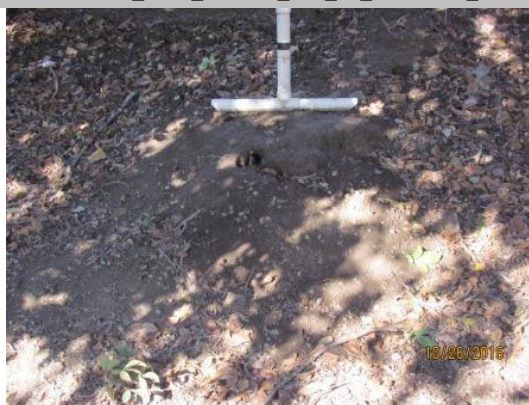
Photo 1 of 1 : SP_2017_ST0003_264_77_20170315_00023.jpg

LM Start	12.04	Rating **	M	Issue No.	77
LM End	12.04	Issue Type +	Ma	Location *	LS
Category	Earthen Levee			GPS Latitude/Longitude	
				Start	End
Item	Animal Control			39.286958 °	39.286958 °
				-122.014033 °	-122.014033 °
DWR ID	DWR_ST0003_01_f_2016_77				
Comment Code					
A3 : No rodents visible, but rodent burrows visible; need to backfill and compact or grout burrows.					
Inspector Comment

View of the rodent holes along the landside slope.

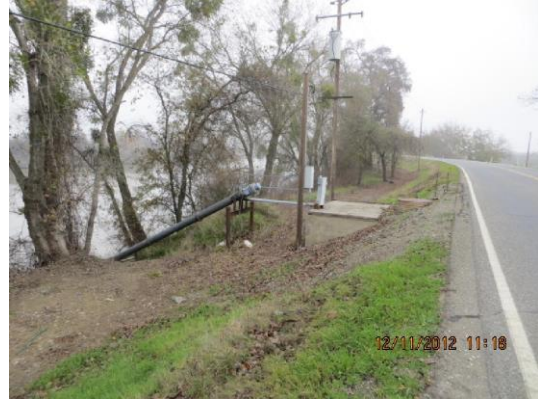
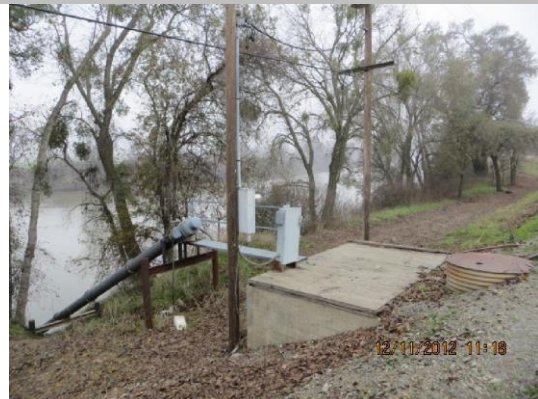
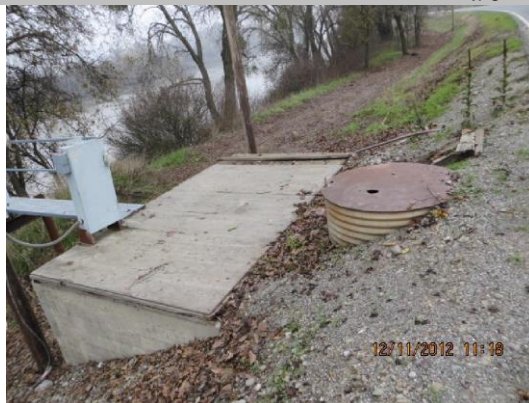
FS_ID:51743
DS_ID:17365
EP_NO: 9514
Repair Type: Non-Urgent
Crossing Status: Found
UCIP Comments: 4/19/2017 Crossing appears to be in good condition.
(DWR Sutter Yard- A Freitag)10/31/2016 Crossing appears to be in good condition.
(DWR Sutter Yard- A Freitag)6/6/2016 Crossing appears to be in good condition. New wooden cover was made for WS surge tank.
4/2/2015 Everything looked to be in good condition. Concrete surge tank still has some silting. Gate valve in CMP riser not visible. Flap gate in concrete distribution box on LS not visible/accessible. Looks like cleaning required inside concrete surge tank on WS due to silting.
7/2/2014 Same as last inspection. 12/30/2013 Same as last inspection. 7/29/2013 Pump running and WS surge tank was full of water so not sure if silt was cleaned out. LS flap gate was visible and is in good condition.
FIELD_STRUCT_DESC: 36-inch corrugated metal irrigation pipe through the levee, 18.1 feet below the crown. Pump house on the waterside (WS) slope. Gate valve in a corrugated metal riser on the WS toe. Flap gate in a concrete distribution box at the landside (LS) toe. (Automatic Board Order (ABO) issued as Permit No. 9514, 1974 - Boggs). [Additional Reference(s): Levee Log, 2002. USACE Sacramento O&M Manual 136, March 1960 (HLM 12.05)].

Waterside view: overview pipe, pump, surge box & CMP riser

Waterside view: steel pipe, pump, surge box & CMP riser

Waterside view: pump switch box, surge box & CMP riser

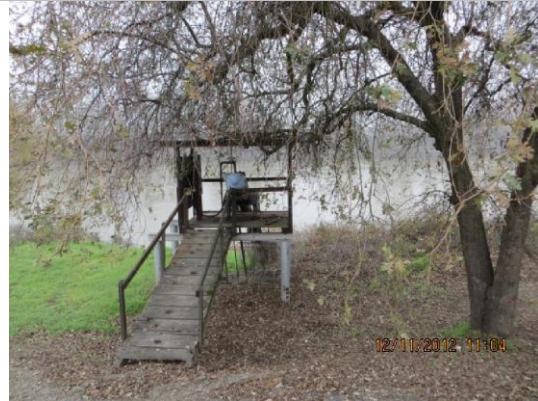
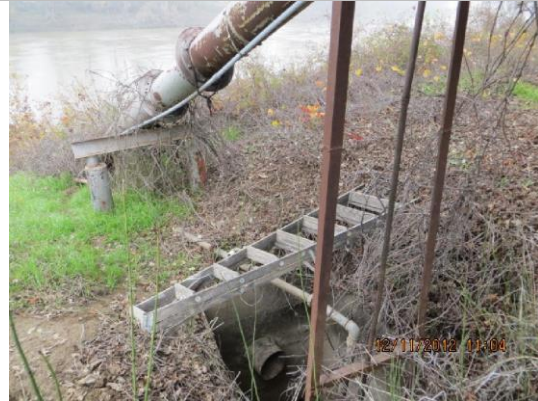
FS_ID:51744
DS_ID:17366
EP_NO: 9513
Repair Type: Non-Urgent
Crossing Status: Found
UCIP Comments: 4/20/2017 2.5in. GI pipe was removed and replaced with a section of 2.5in. flexible hose that can easily be removed to allow the slide gate to fully close for high water season. (DWR Sutter Yard- Afreitag)10/31/2016 2.5in. pipe still blocking the screwgate. (DWR Sutter Yard- Afreitag)6/6/2016 2.5inch pipe still present through crossing. (DWR Sutter Yard - afreitag)4/14/2016 2.5-inch pipe still preventing slide gate from fully closing on WS. Recommend LMA contact owner to address removal of unauthorized 2.5-inch pipe. Owner must either contact CVFPB for permitting of 2.5-inch pipe or remove it. (DWR UCIP - kfazel)4/2/2015 2.5in pipe is still present and prevents the slide gate from fully closing. (DWR Sutter Yard - afreitag)7/2/2014 2.5in. GI pipe and chain in WS surge box will prevent slide gate from closing fully for high water season. (DWR Sutter Yard - afreitag)12/30/2013 Same as last inspection. (DWR Sutter Yard - afreitag)7/29/2013 2.5in. GI pipe and chain in WS surge box will prevent slide gate from closing fully for high water season. (DWR Sutter Yard - afreitag)12/11/2012 A 2.5 inch GI pipe through 36 inch CMP found. A 2 inch electrical conduit also found. (DWR UCIP - pamatya)

FIELD_STRUCT_DESC: 24-inch corrugated metal irrigation pipe through the levee, invert 16.5 feet below the crown. Slide gate in a concrete surge box on the waterside (WS) berm. 2.5-inch pipe through the 24-inch pipe preventing closing of the slide gate on the WS. Slant pump on the riverbank. Concrete distribution box at the landside (LS) toe. 2-inch electrical conduit through the levee, visible on the WS adjacent to the walkway. (Automatic Board Order (ABO) issued as Permit No. 9513, 1974 - Boggs). [Additional Reference(s): DWR Levee Log, 2002. USACE Sacramento O&M Manual 136, March 1960 (HLM 12.42)].
FS Date: 5/1/2017 9:58:54 AM

Waterside view: overview of slanted pump and shed

Waterside view: pump station and walkway

Waterside view: steel pipe, GI pipe in concrete surge box

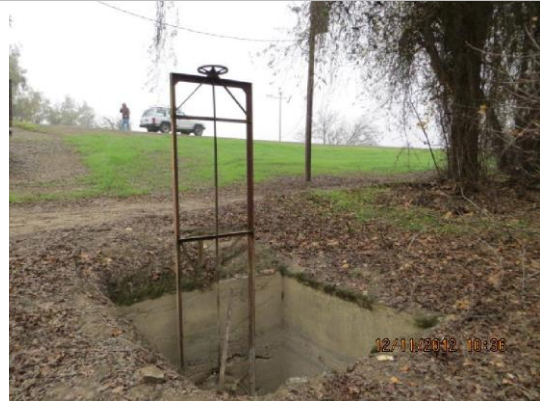
UCIP Comments: 4/20/2017 Sink hole behind the WS surge box got a lot bigger after the high water event of Jan/Feb 2017. Pipe also had a leak during that time but not sure if it was due to the sink hole or a faulty slide gate. (DWR Sutter Yard- A Freitag)10/31/2016 No repairs have been made here yet. Sinkhole is still present at the WS surge box. (DWR Sutter Yard- A Freitag)6/6/2016 Pumps were connected to intake pipes and pumping into the WS surge box. The deep sink hole above the surge box measures to be about 6'6" deep from the toe road surface and it appeared to be wet in the bottom indicating the cracks in the concrete may be letting water seep through and wash out the sediment behind the wall. The surge box was full of water so could not observe the sediment build up in the bottom of the box. (DWR Sutter Yard - a Freitag)4/14/2016 Deep sink hole above surge box on WS, possibly caused by burrowing, possibly creating conduit for seepage into surge box, which may explain presence of water in box. Recommend pipe be video inspected. Recommend taking another photo in summer to observe possible sediment buildup in box. (DWR UCIP - k fazel)4/2/2015 Pipe has small leak during times of high water. Not sure of the cause. Pumps taken out from the pipe (may be for repairs). Only control board found. LS wing wall minor damage. (DWR Sutter Yard - a Freitag)7/2/2014 Same as last inspection. (DWR Sutter Yard - a Freitag)12/19/2013 Same as last inspection. (DWR Sutter Yard - a Freitag)7/23/2013 Pump motors attached to pipes and running. Think pumps were disconnected during last inspection to keep motors above water for high water season. (DWR Sutter Yard - a Freitag)12/11/2012 Pumps taken out from the pipe (may be for repairs). Only control board found. LS wing wall minor damage. (DWR UCIP - pamatya)

Waterside view: overview

Waterside view: concrete surge box

Waterside view: slide gate in concrete surge box

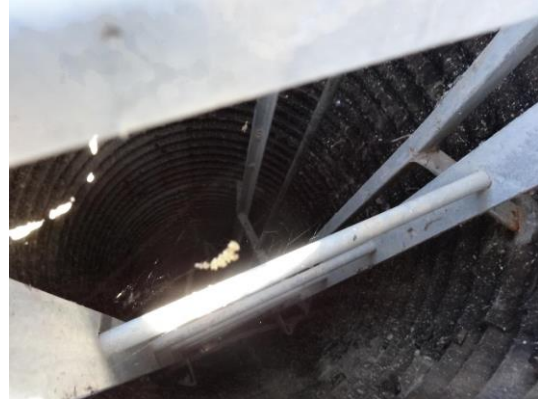
FS_ID:51747
DS_ID:17368
EP_NO: N/A
Repair Type: Non-Urgent
Crossing Status: Indicator Found
UCIP Comments: 4/20/2017 Abandoned- needs to be done properly. (DWR Sutter Yard- A Freitag)10/31/2016 Appears abandoned. (DWR Sutter Yard- A Freitag)6/14/2016 Pipe was internally cleaned and camera inspected on 11/5/2015 by Nor-Cal Pipeline Services. Pipe length is 86.7ft long. There is a possible sag in the pipe between the WS riser and LS end as we could not get all the water to drain or be sucked out after the cleaning was done. Internal inspection showed signs of some rusting but no visible holes or other deterioration were found. After the inspection pipe ends were capped and reburied. 4/14/2016 Same as last inspection. Heavy vegetation along WS slope, especially below WS berm, limits visibility. 4/2/2015 WS and LS pipe ends have been dug up in preparation for internal camera inspections. Only CMP riser found. 7/2/2014 Same as last inspection. 12/19/2013 Same as last inspection. 7/23/2013 Same as last inspection.

FIELD_STRUCT_DESC: *ABANDONED* 12-inch drainage pipe of an unknown material through the levee, 14 feet below the crown, not found in 2016. Slide gate in a corrugated metal pipe riser (CMP) on the waterside (WS) slope, found in 2016. [Additional Reference(s): DWR Levee Log, 2002. USACE Sacramento O&M Manual 136, March 1960 (HLM 12.73)].
FS Date: 5/1/2017 10:19:49 AM

View of landside from crown.

WS view: 12-inch slide gate inside CMP riser on WS slope.

WS: slide gate inside CMP riser.

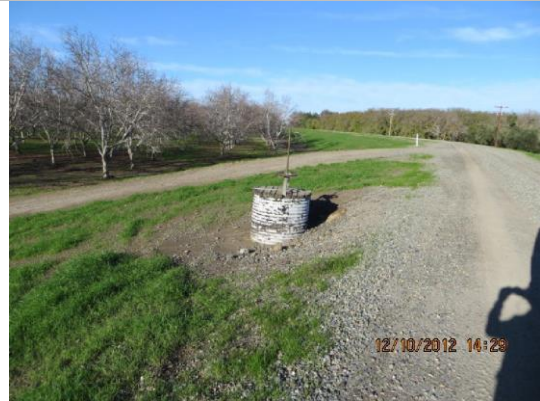
FS_ID:51748
DS_ID:17369
EP_NO: 9510
Repair Type: Urgent
Crossing Status: Found
UCIP Comments: 4/20/2017 Erosion hole at WS surge box has gotten worse after the Jan/Feb 2017 high water event. Pipe also leaked which is believed to be caused by the screwgate not fully closing. (DWR Sutter Yard- AFreitag)10/31/2016 No repairs have been made here yet. Bad erosion still present at the WS toe distribution box.(DWR Sutter Yard- AFreitag)6/3/2016 Bad erosion still present all around the WS surge box. Pipes were flowing water at the time of inspection and the bottom of the erosion hole was wet and had standing water in it indicating a leak coming from the surge box. (DWR Sutter Yard - afreitag)4/14/2016 Heavy scour still present around surge box on WS exposing pipe. Levee caved in and severely damaged around surge box. Erosion around CMP riser on WS cited previously not found. (DWR UCIP - kfazel)4/2/2015 Pipe leaks during high water. It is suspected that the screw gate does not fully close and may need to be cleaned to allow it to close fully. (DWR Sutter Yard - afreitag)7/2/2014 Same as last inspection. (DWR Sutter Yard - afreitag)12/19/2013 Same as last inspection. (DWR Sutter Yard - afreitag)7/23/2013 Water was flowing from the WS to LS ditch. Not sure where water flow was originating. All erosion problems are still present. (DWR Sutter Yard - afreitag)12/10/2016 Soil erosion around CMP riser and surge concrete box on WS damaged due to overflow. Pump not found. Flap gate missing on WS concrete box. WS slope eroded. Structure might have been used as drainage structure. This needs to be determined during routine inspection. (DWR UCIP - pamatya)

FIELD_STRUCT_DESC: 36-inch corrugated metal irrigation pipe through the levee, 18 feet below the crown. Slide gate in a 48-inch corrugated metal pipe (CMP) riser on the waterside (WS) slope. Concrete box on the WS. Pump mounted on the WS bank, not found in 2016. (Automatic Board Order (ABO) issued as Permit No. 9510, 1974 - Forry). [Additional Reference(s): DWR Levee Log, 2002. USACE Sacramento O&M Manual 136, March 1960 (HLM 12.95)].
FS Date: 5/1/2017 10:21:15 AM

Waterside view: CMP riser on levee slope.

Waterside view: overview of concrete surge box

Waterside view: concrete surge box

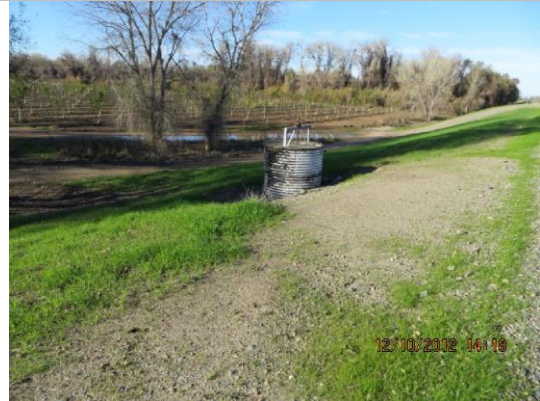
FS_ID:51749
DS_ID:17340
EP_NO: 9511
Repair Type: Non-Urgent
Crossing Status: Found
UCIP Comments: 4/20/2017 Abandoned- needs to be done properly. A oak tree has fallen down onto the WS pipe end. It does not appear to have damaged the pipe but it will need to be better inspected after the tree has been cleared away. (DWR Sutter Yard- AFreitag)10/31/2016 Abandoned. (DWR Sutter Yard- AFreitag)6/14/2016 Pipe was internally cleaned and camera inspected on 11/6/2015 by Nor-Cal Pipeline Services. The 48" cmp pipe section that runs through the levee was deemed to be in good condition. After the LS levee toe the pipe changes to a 48" concrete box culvert for under the roadway and that showed signs of some cracking. After the inspection the WS end was capped to keep sediment out until further abandonment can be achieved.4/16/2016 A wooden board has been placed on WS outlet of pipe to prevent sediment from entering pipe. This is a temporary repair measure by Sutter Yard until pipe can be grouted. Need to contact owner to ensure pipe's proper abandonment. Blockage of pipe outlet by wooden board or sediment will pose a hazard during high water. Pipe owner unclear, as landowner differs on LS and WS.4/2/2015 Pipe has been selected for internal camera inspection.Outlet pipe silted on WS. Inlet structure damaged on LS. Not properly abandoned.7/2/2014 Same as last inspection.12/19/2013 Same as last inspection.7/23/2013 Same as last inspection.

FIELD_STRUCT_DESC: *ABANDONED* 48-inch corrugated metal drainage pipe through the levee, 16.5 feet below the crown. Slide gate in a 60-inch corrugated metal pipe (CMP) riser on the waterside (WS) slope. Landside (LS) end of pipe on east side of River Road. Pipe is not in use but is operable. (Permit No. 9511, 1974 - Moresco). [Additional Reference(s): DWR Levee Log, 2002. USACE Sacramento O&M Manual 136, March 1960 (HLM 13.37)].
FS Date: 5/1/2017 10:27:34 AM

Waterside view: CMP riser with slide gate

Waterside view: overview of CMP riser and outlet pipe

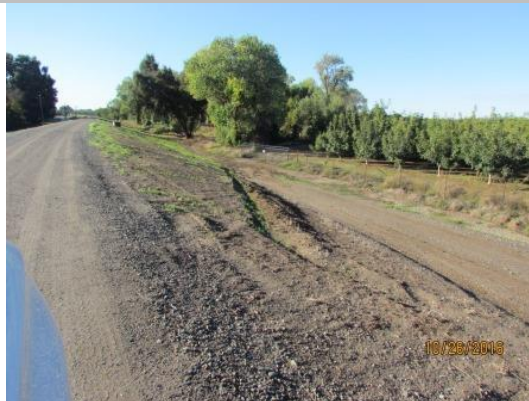
Photo 1 of 1 : SP_2017_ST0003_264_75_20170315_00021.jpg

LM Start	13.43	Rating **	M	Issue No.	75
LM End	13.43	Issue Type +	Ma	Location *	WS
Category	Earthen Levee			GPS Latitude/Longitude	
				Start	End
Item	Slope Stability			39.306919 °	39.306919 °
				-122.013076 °	-122.013076 °
DWR ID	DWR_ST0003_01_f_2016_75				
Comment Code					
S3 : Repair the levee slope damaged by vehicle traffic and prevent access where possible.					
Inspector Comment

View of the slope instability along the waterside slope.
